Overview of Existing Conditions and School Needs

Existing Facility Deficiencies

The school department has aging school infrastructure that is failing and affecting the safety and wellbeing of occupants as well as weighing heavily on operating budgets

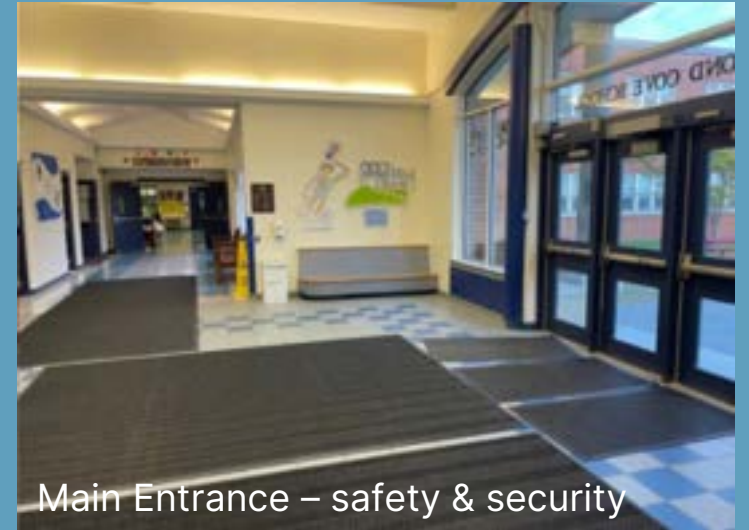
Main Entrance – safety & security

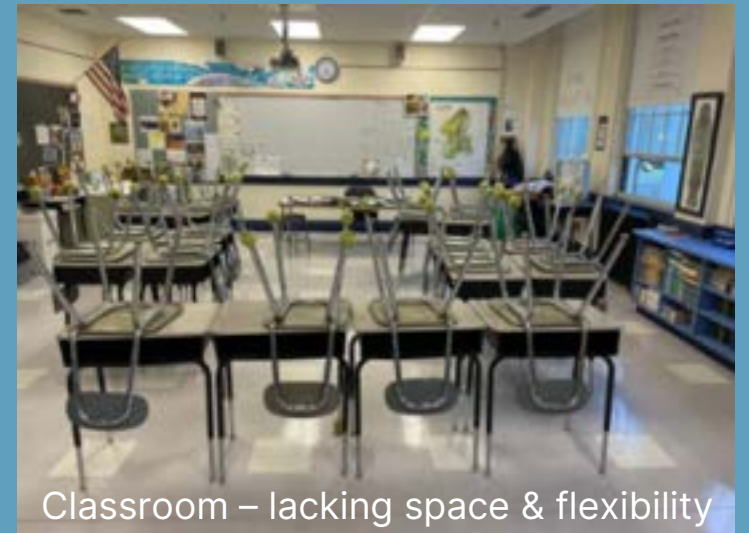
Classroom – lacking space & flexibility

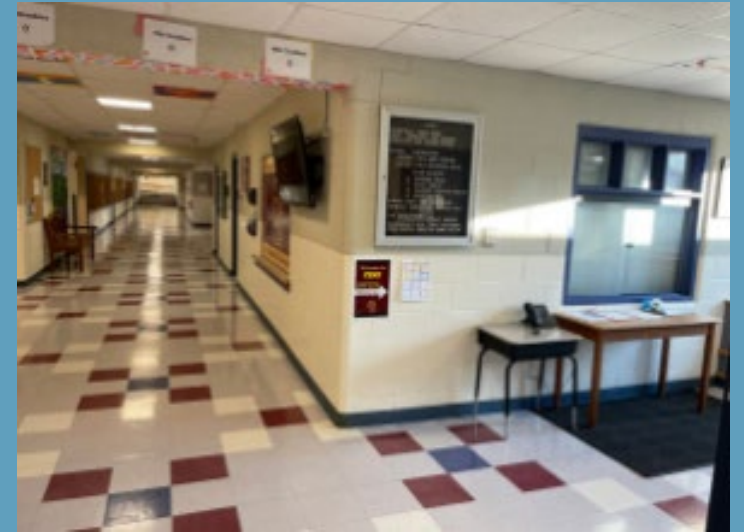
- Are not connected and /or located at the front entrance **posing a significant management & safety challenges.**
- Updated offices and main entrances will allow for a “safety-first” design. Sight lines to the parking lot, parent drop-off, and bus loop are imperative. A suite style office would improve privacy & efficiency.

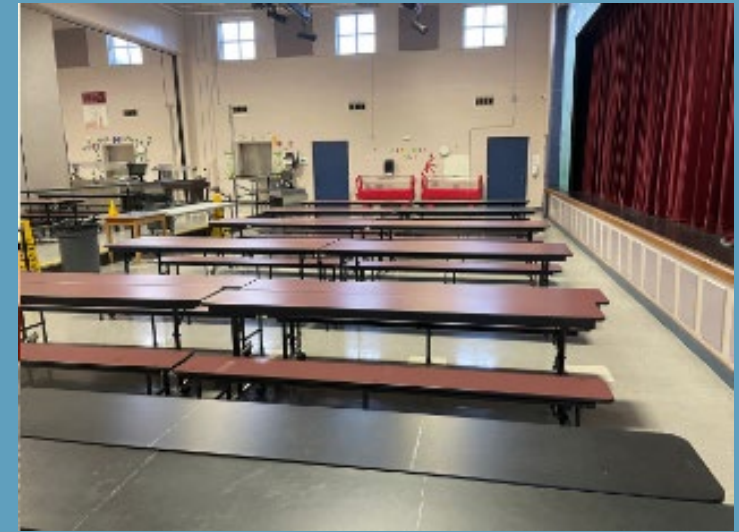
7. Cafetorium: Shared by CEMS and Pond Cove. **Entire schedule is built around an hour window during which students in all four grade levels must be served and eat lunch.** (Food deliveries through hallway of middle school – safety concern).
8. Storage Problems: Adequate storage in the vicinity of staff who utilize it is paramount to a smooth and efficient workflow.
9. Technology Upgrades: A future-focused design will ensure classrooms & other learning spaces have the latest technology to promote inquiry, analysis, collaboration, creativity, communication & preparation for future careers.
10. HVAC: The ineffectiveness, age and sound levels of the current HVAC system has direct & negative impacts on student and staff.

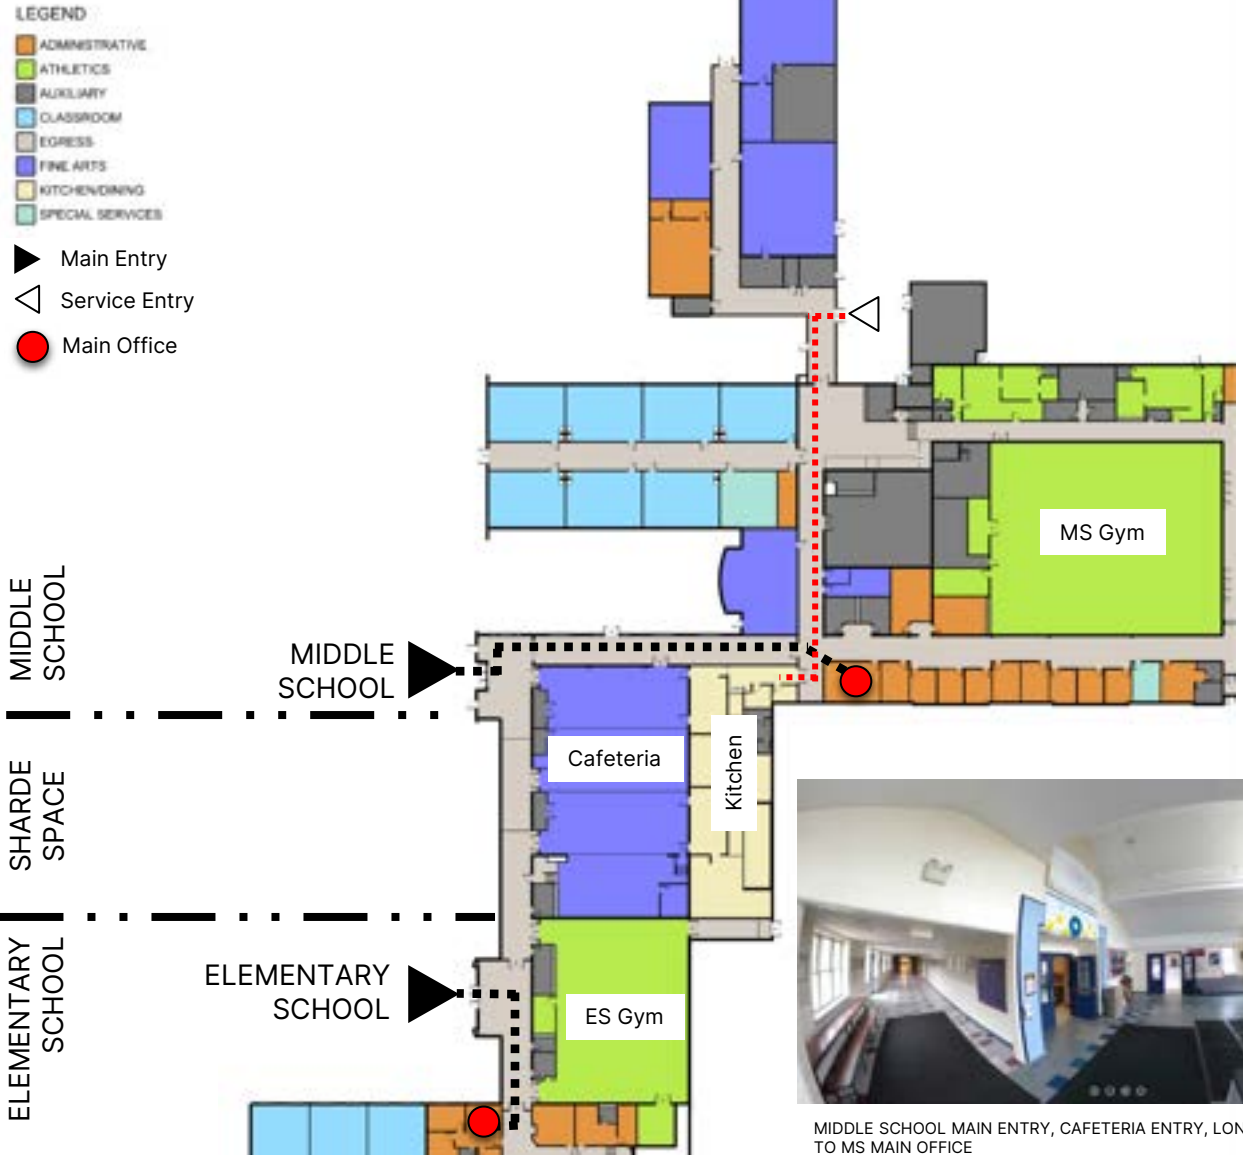
- Comprehensive site and building approach needed.
- Distance from main entry to office
- Lack of separation of private and public spaces
- Lack Secure vestibules
- Deliveries traversing through school
- Lack of compartmentalization of school
- Lack of zoned public address
- 1994 addition done prior to Columbine.
- And more.

*upgrades to camera system, communication systems, and entry doors have been made.

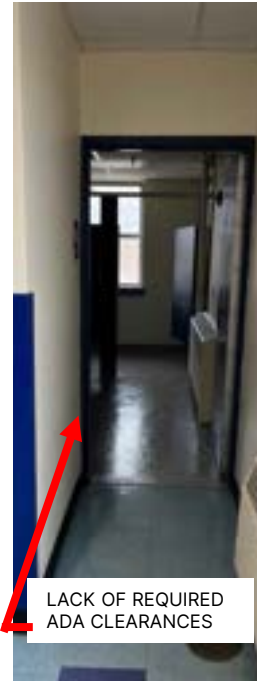
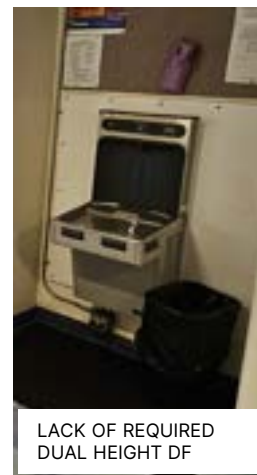
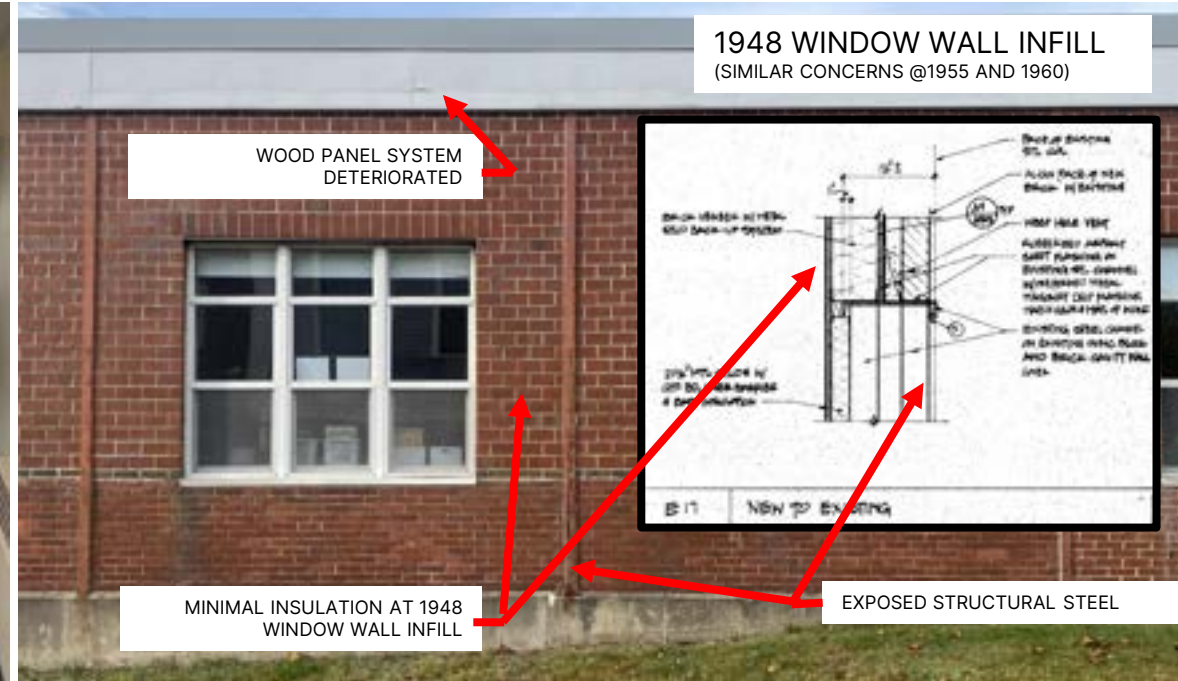
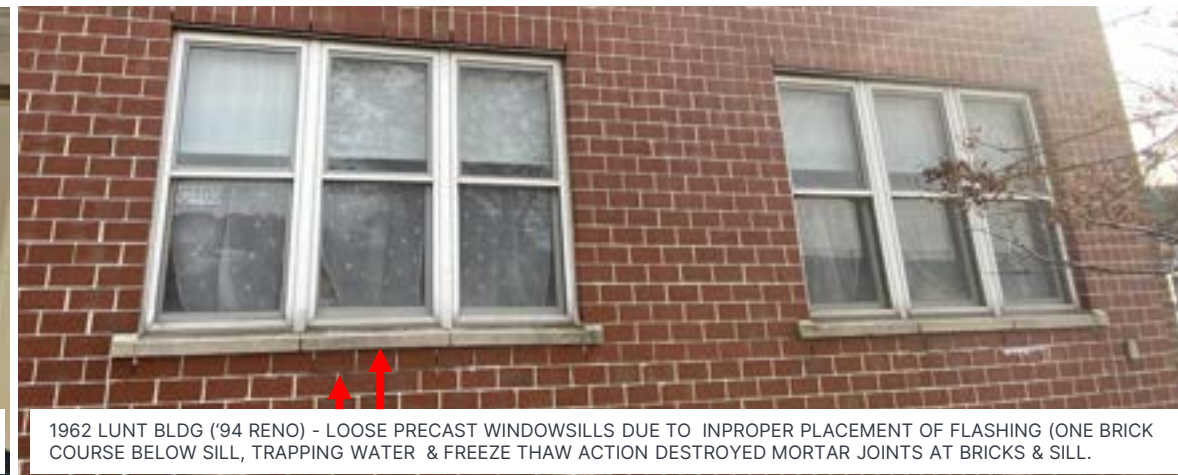
- Water intrusion
- Thermal Bridging
- Deterioration
- Insulation Values not Code compliant

- Restroom approach
- Door clearances
- MS Lack of dual height drinking stations on each floor.
- Misc. fixture flush handles and grab bar locations
- And more

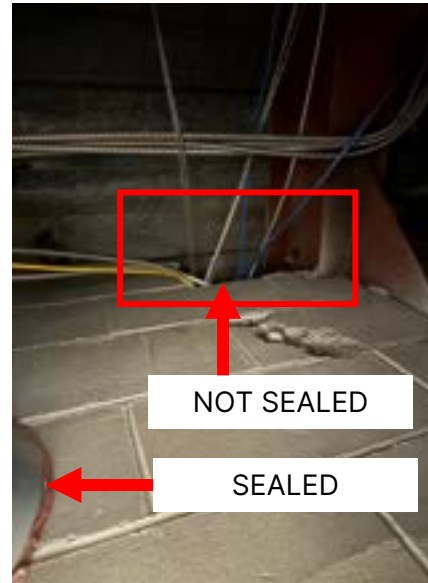
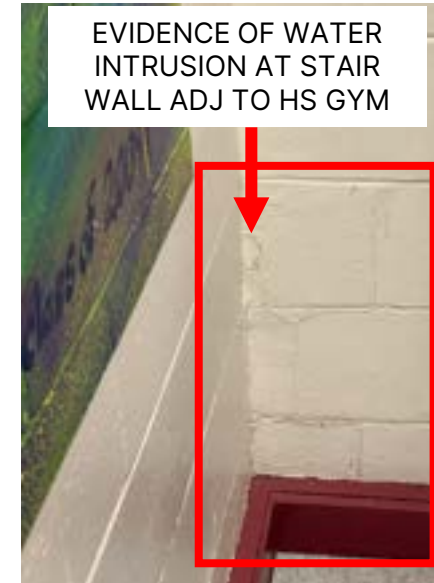
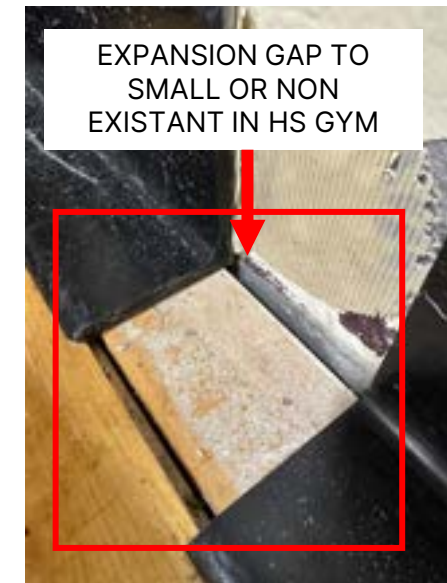
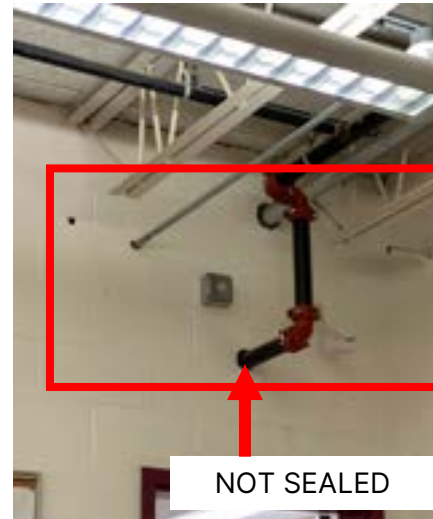
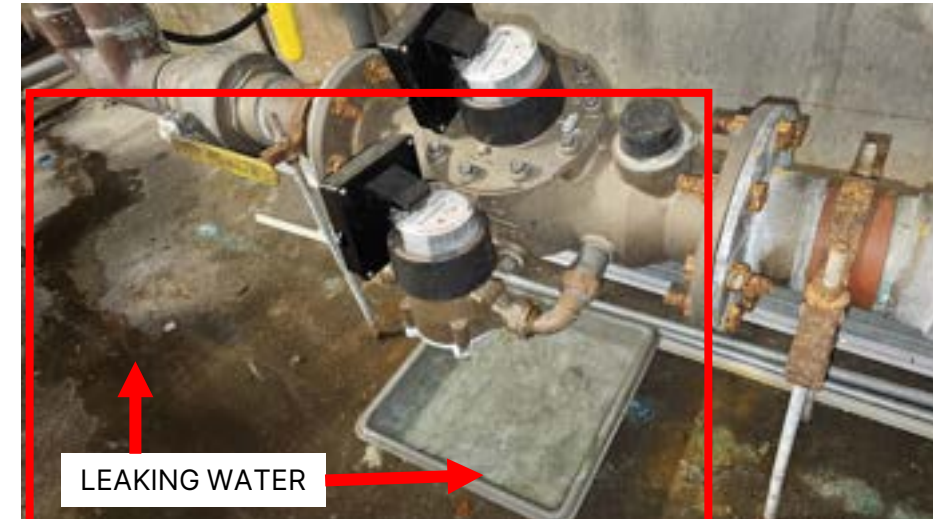
- Fire and smoke separation not code compliant.

- Installation
- Moisture / Humidity
- Signs of Water intrusion

- Repair the leaking water piping in the high school water entrance room.

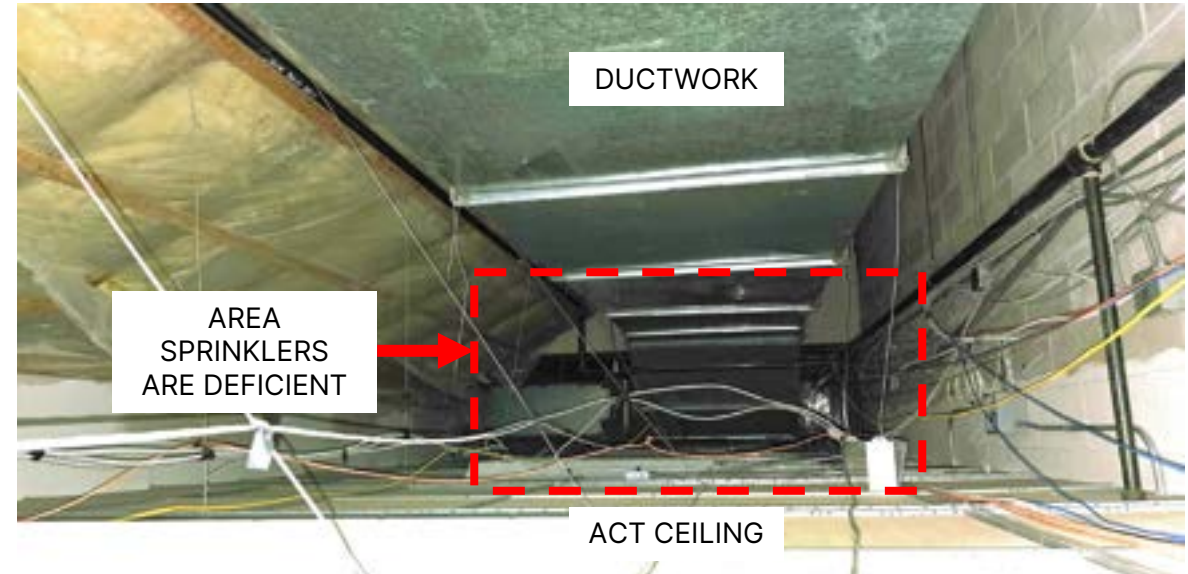
- Install sprinklers below ductwork above the ceiling of the middle school corridor
- Install a fire protection system in the pool building addition.

- Repair the leaking water piping in the high school water entrance room.

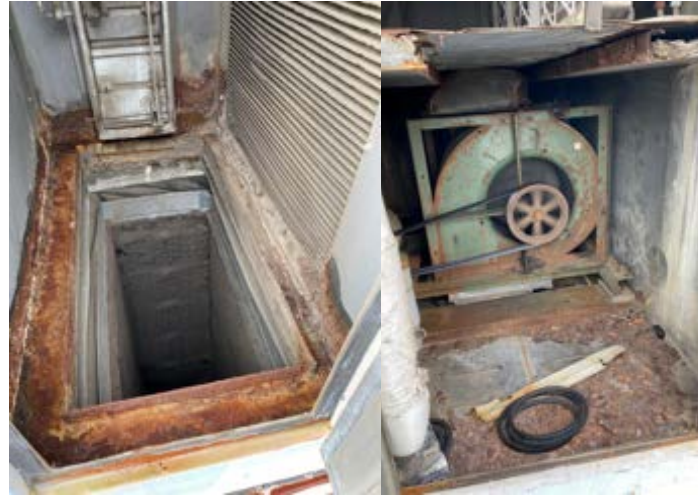
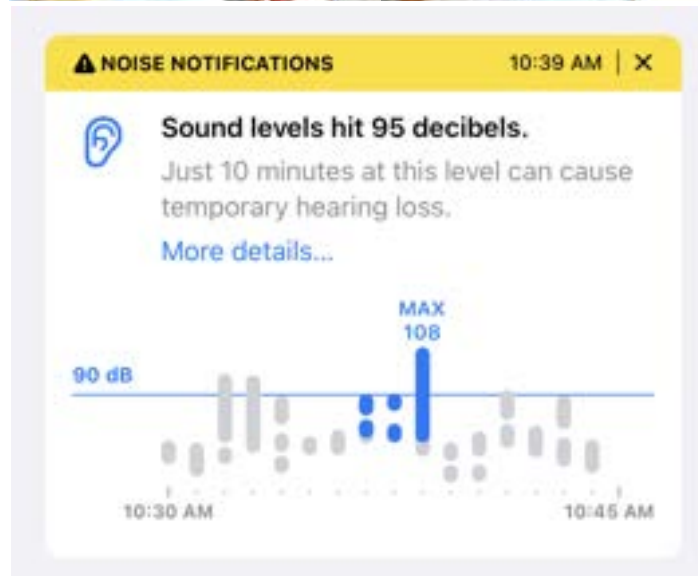
- Rooftop Heat Recovery Units (ERVs) at Middle/Elementary School have **aged out and need to be replaced**. Some are **loud** and others are **corroding from the inside out**.
- Overall aging equipment
- Lack of heat in the 4th grade wing. May require an upgrade to the main pumps.

MS/PC: HRU-3 is loud (108 dB at the fan as measured by iPhone).

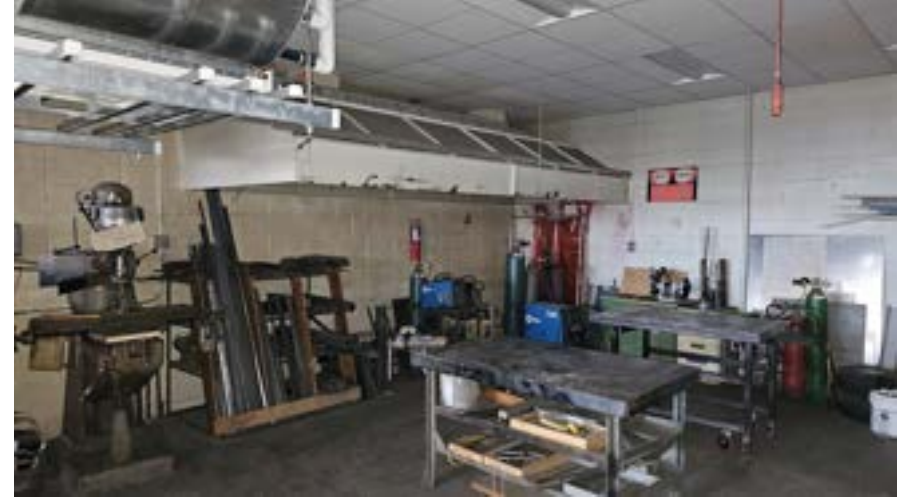
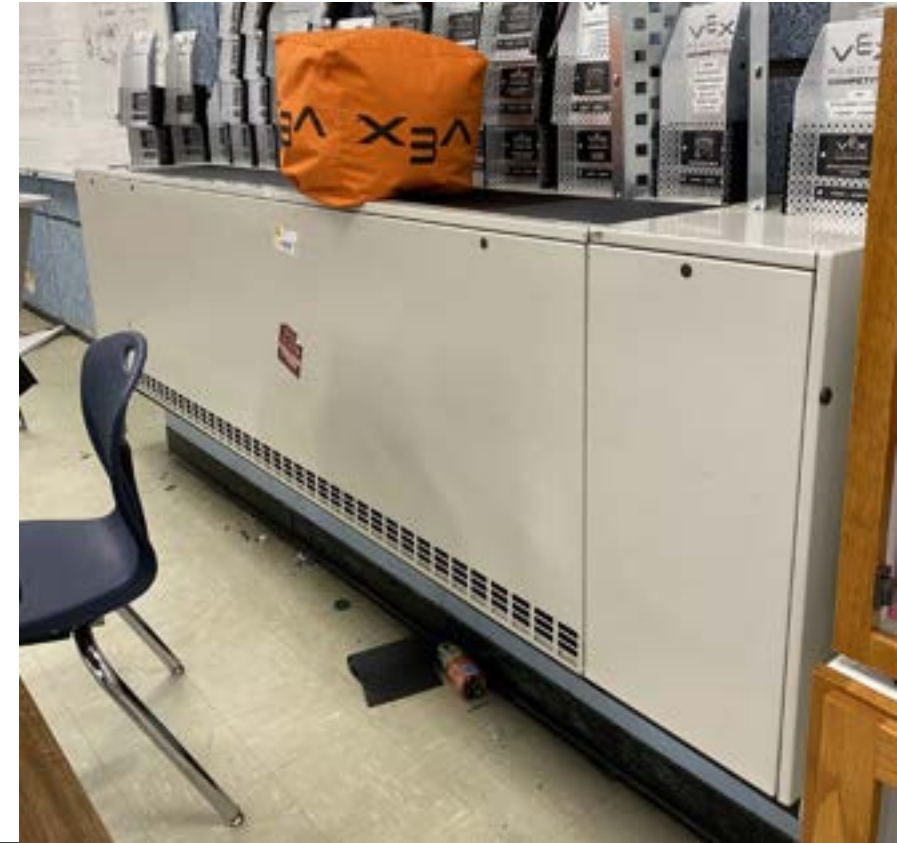
- Provide exhaust capture systems for metal shop.
- Gas tank storage

- Provide cooling where it is deemed appropriate.

- Upgrade High School unit ventilators to provide more outside air. Existing UV provides an average of 250 CFM of outdoor air. Current standards for a 25-occupant classroom require 340 CFM.

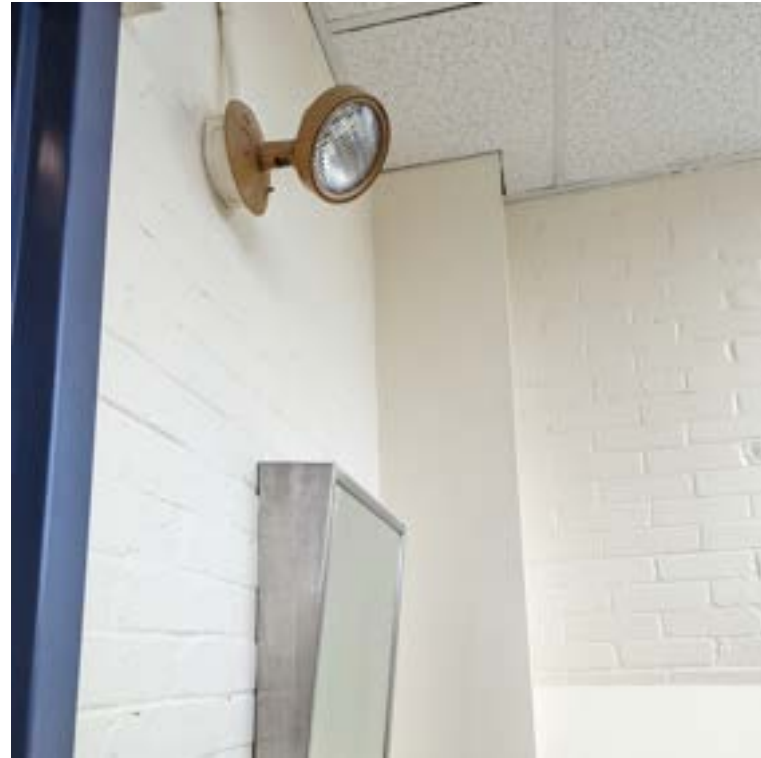
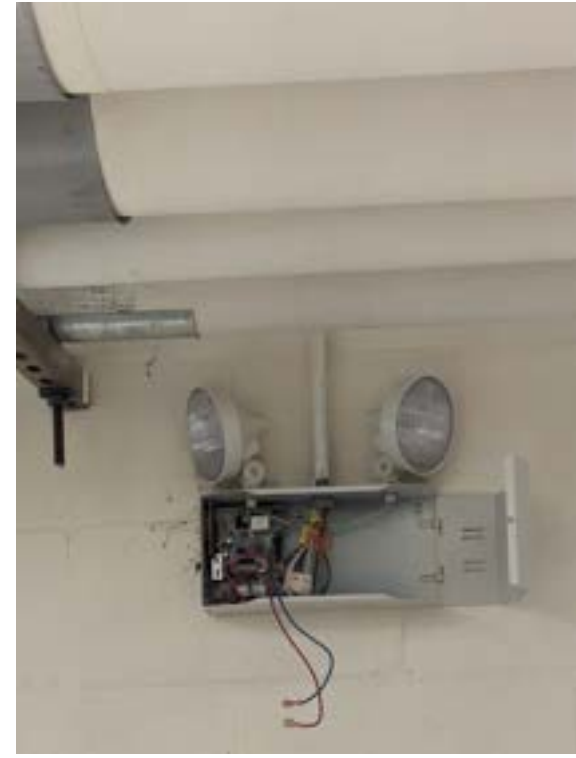
- Replace aging emergency egress lighting system with remote battery head LED units in all buildings.

- Add additional Fire Alarm Audio/Visual appliances (Horn Strobes) in all classrooms (current distribution is inconsistent) and multi-stall bathrooms in accordance with NFPA 72 and ADA requirements in all buildings. Add smoke detectors at FACP panels (MS/ES) and carbon monoxide/gas detection to kitchen areas in all buildings. Add additional Fire Alarm Annunciators to MS and ES (per Fire Department's request).
